## RED HOT SUPERHEATER COILS - DESIGN FAILURES

RECENTLY COMMISSIONED 45 TPH AFBC BOILER

### A CASE OF DESIGN FAILURE:

## **RED HOT SUPERHEATER COILS in OPERATIONAL TG BOILER**

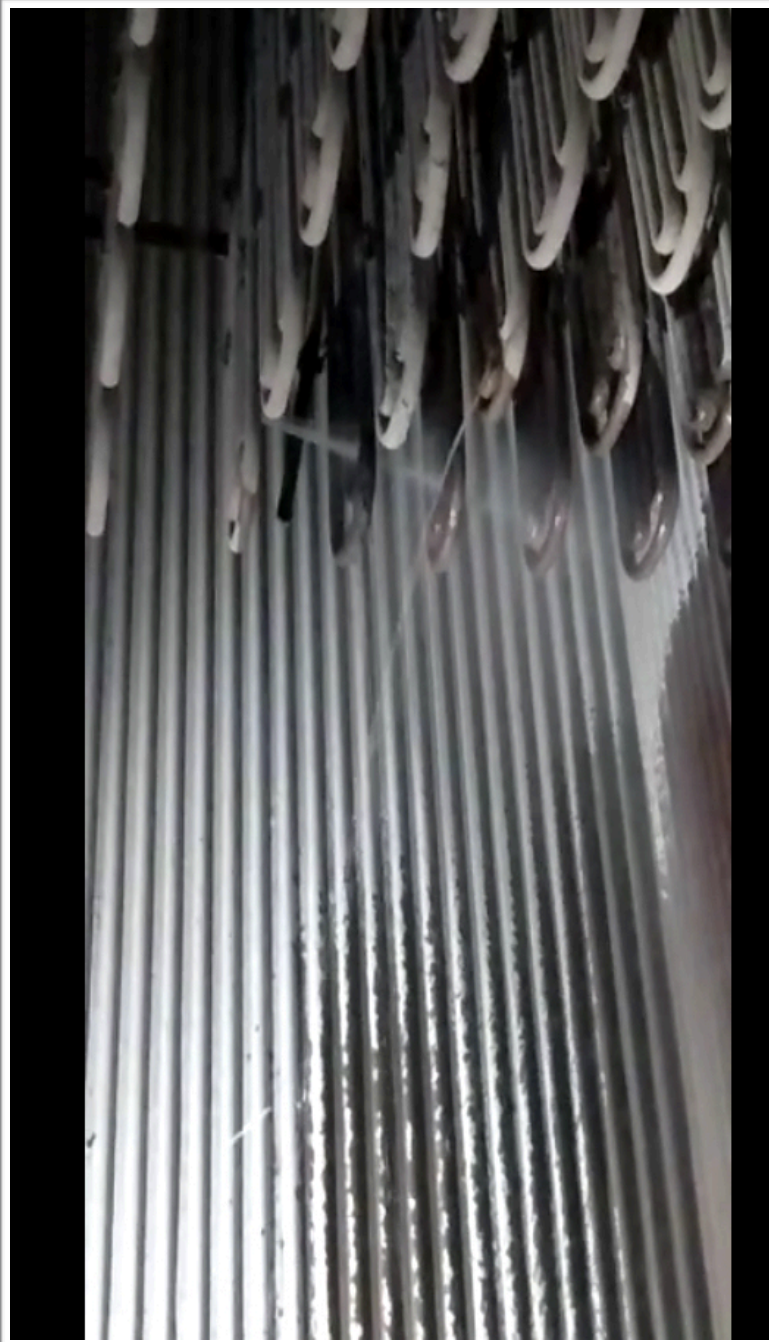
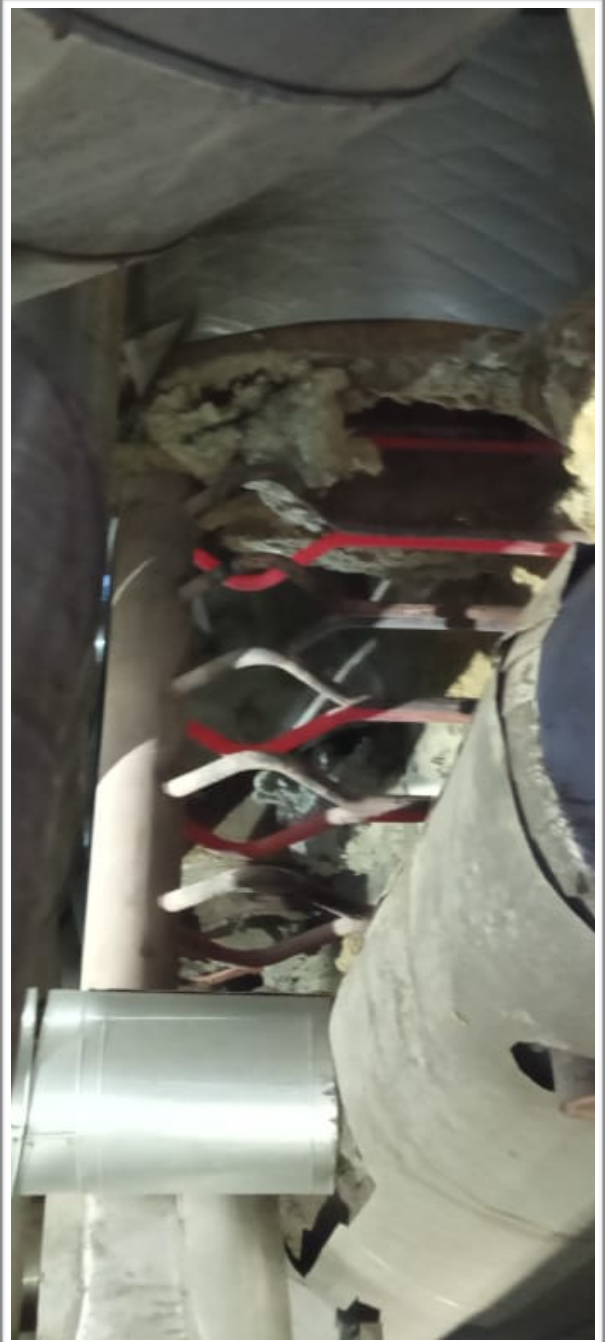
High Velocities of steam inside tubes causing less cooling of coils thus metal temperatures remain on higher side.

Higher velocity of Steam, Higher pressure drop across superheater coils & Less Flow of Steam is the culprit.

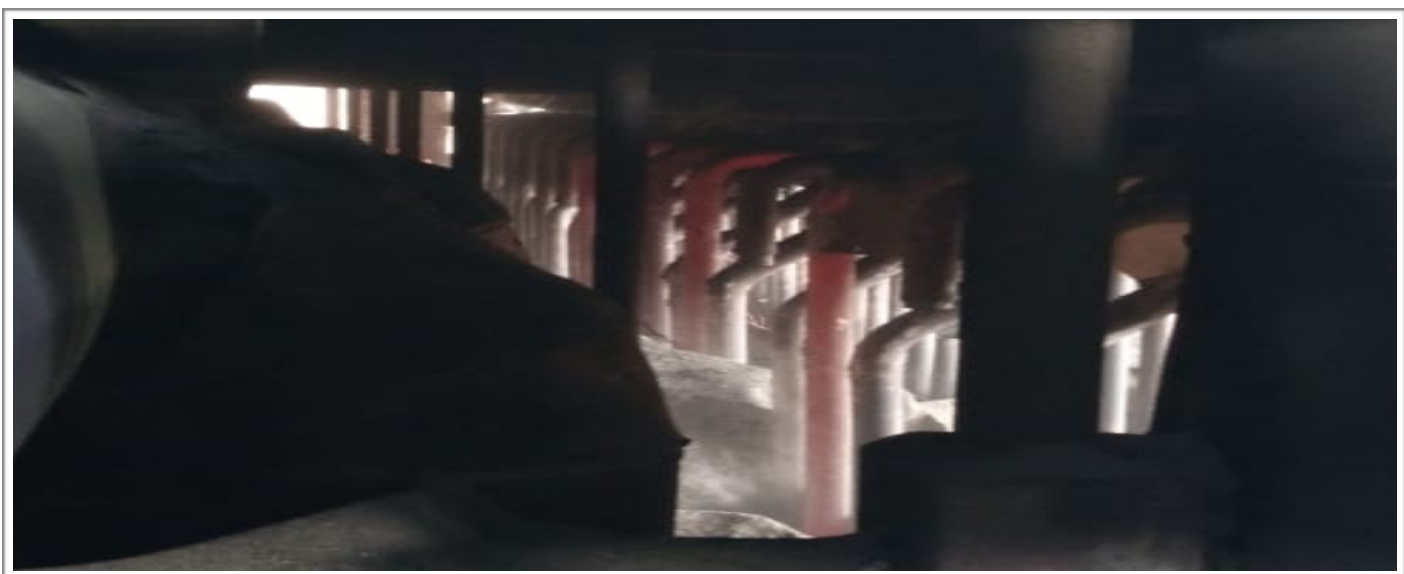
### **A CASE OF LOW LOAD OPERATION FAILURE:**

Low velocities of steam inside tubes causing less cooling of coils thus metal temperatures remain on higher side.

Lower velocity of Steam & Low pressure drop across superheater coils & Less Flow of Steam is the culprit.

**“Both High Pressure Drop & Low Pressure Drop are dangerous for Boiler’s Pressure Parts Life”.**

**Keep a watch on Pressure drop always w.r.t. DESIGN & Allowable VELOCITIES**
