## **APH - Air Preheater TUBE FAILURES in BOILER**

### **Root Cause Analysis of APH Tubes w.r.t Design & Operation**

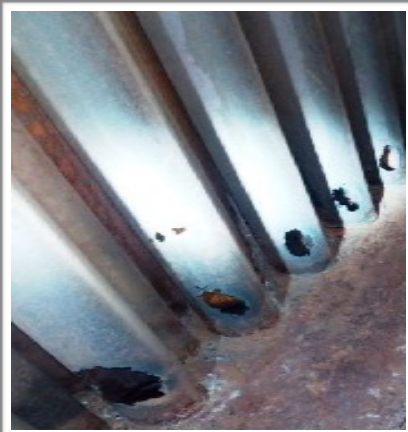
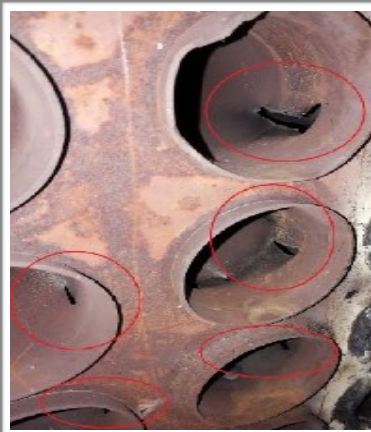
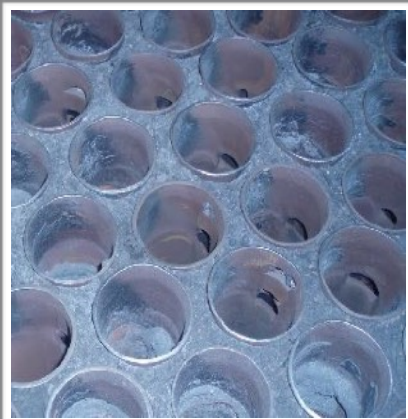
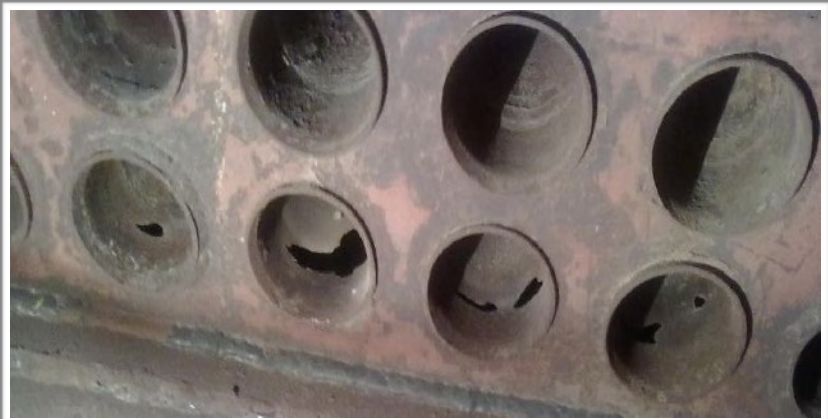
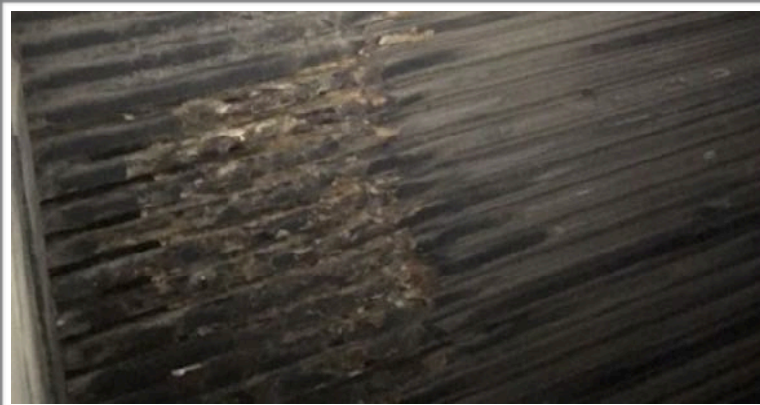
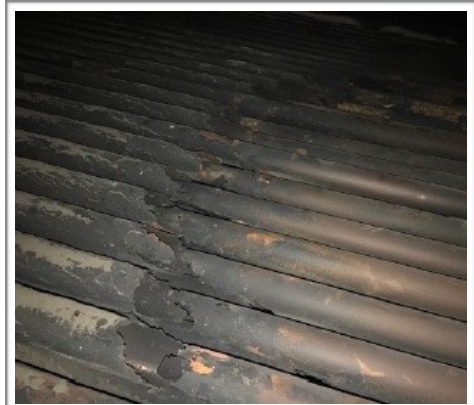
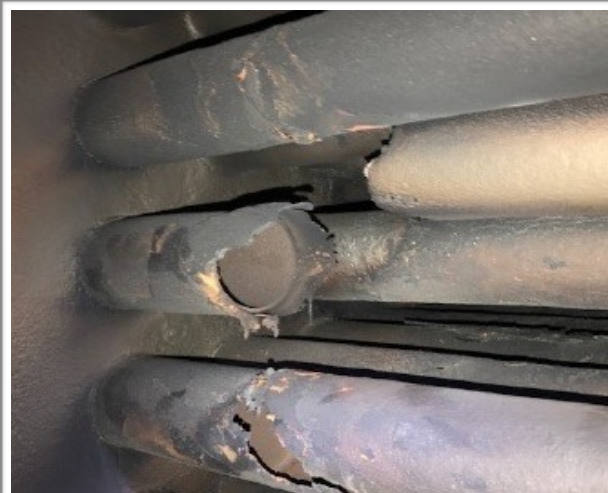
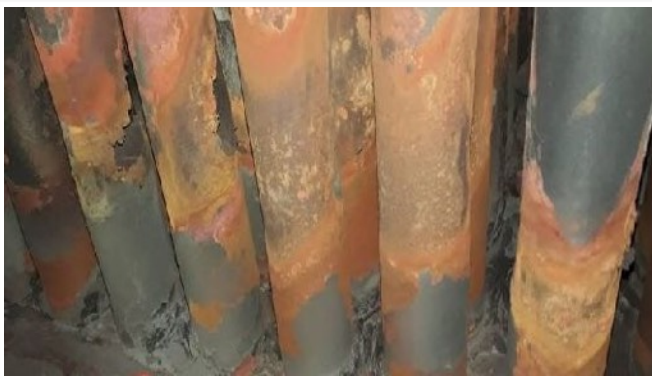
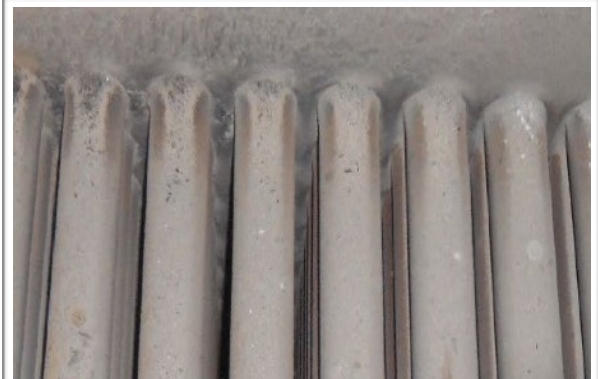
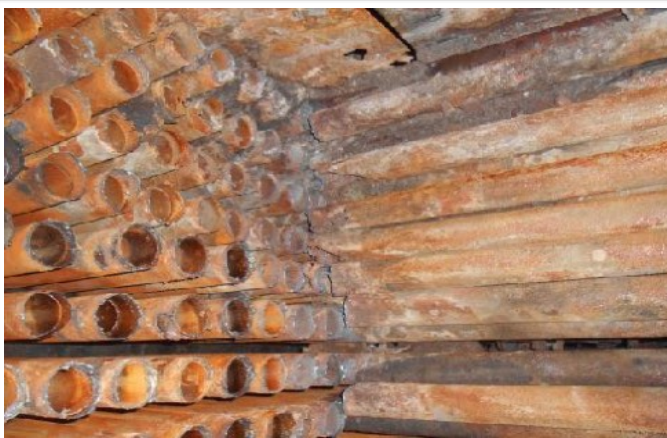
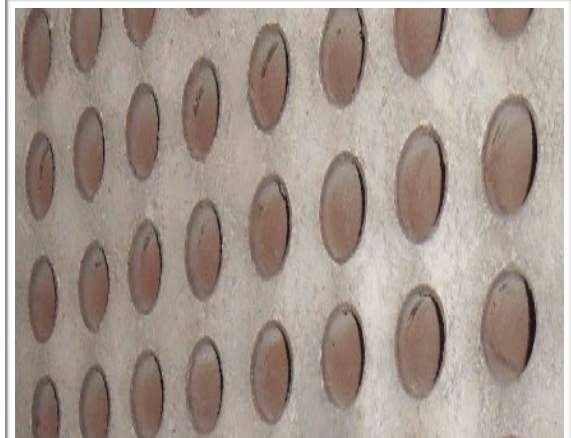
Photos showing Failure due to Expanding, Erosion, High Velocity

### Root Cause Analysis & Reasons of APH Tube Failures

1. Tube Expanding in tube sheet (Thickness reduction to tube failure)
2. Air Turbulence due to Sleeve (Erosion from tube inside)
3. Tube sheet, APH casing expansion restriction (Cracks in tube at end)
4. Damage started in most of the tubes from inside not outside.
5. High Air velocity / gas velocity in tubes (Erosion in tube)
6. Unbalance Air Flow at tube sheet entry (Localise high air velocity)
7. Unbalance Gas Flow at tube sheet entry (Localise high gas velocity)
